SCREENING SITE INSPECTION REPORT
FOR
SOUTH DAYTON DUMP
MORaine, OHIO
U.S. EPA ID: OHD980611388
SS ID: NONE
TDD: FO5-8611-174
PAN: FOH0521SB

SEPTEMBER 23, 1991

ecology and environment, inc.

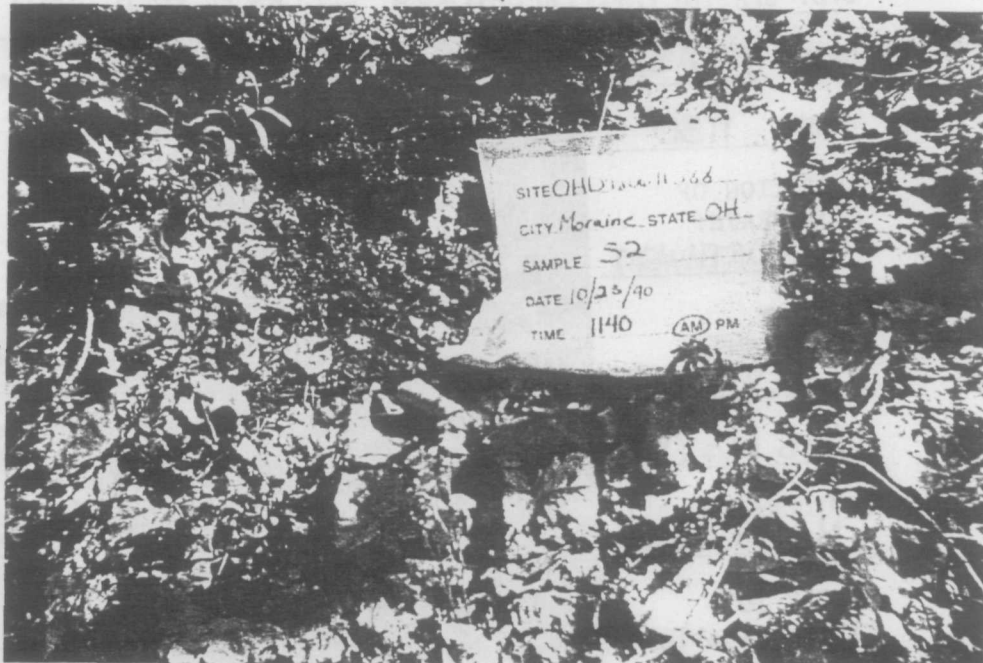
SAMPLE ID
(if applicable):
S2

DESCRIPTION: CLOSE-UP VIEW OF SOIL SAMPLE S2 COLLECTED IN
PIT NEAR WESTERN EDGE OF SITE. (PERSPECTIVE VIEW DID NOT
DEVELOP).

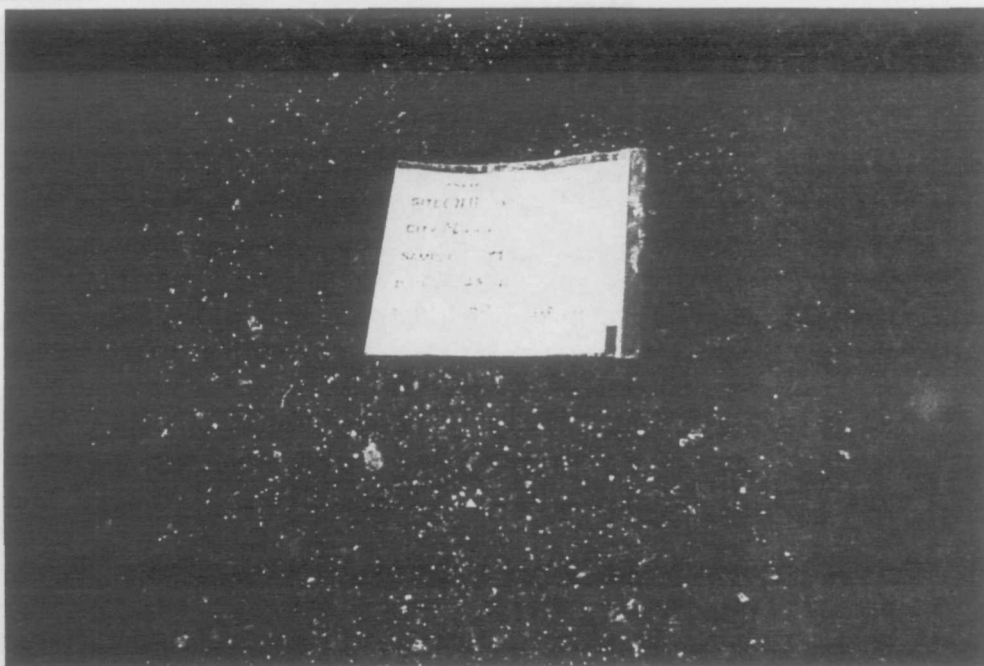
DESCRIPTION: CLOSE-UP VIEW OF SOIL SAMPLE S4 COLLECTED
FROM PILE OF BLACK COARSE MATERIAL.DATE: 10/23/90TIME: 1150DIRECTION OF
PHOTOGRAPH:WEST/NORTHWEST

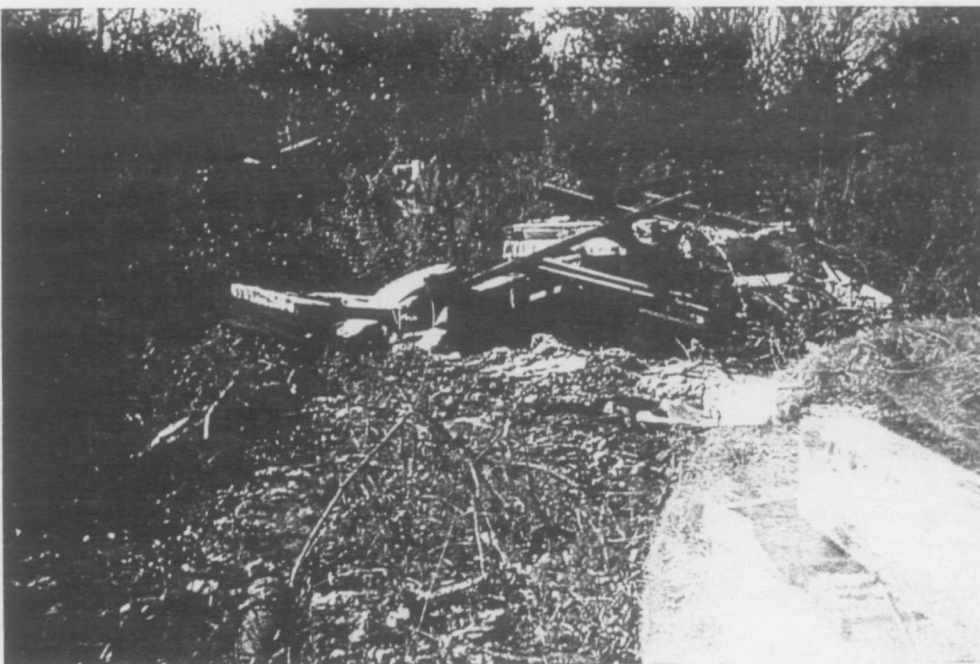
DESCRIPTION: PERSPECTIVE VIEW OF SOIL SAMPLE S6 (NOTE
MISC. DEBRIS).

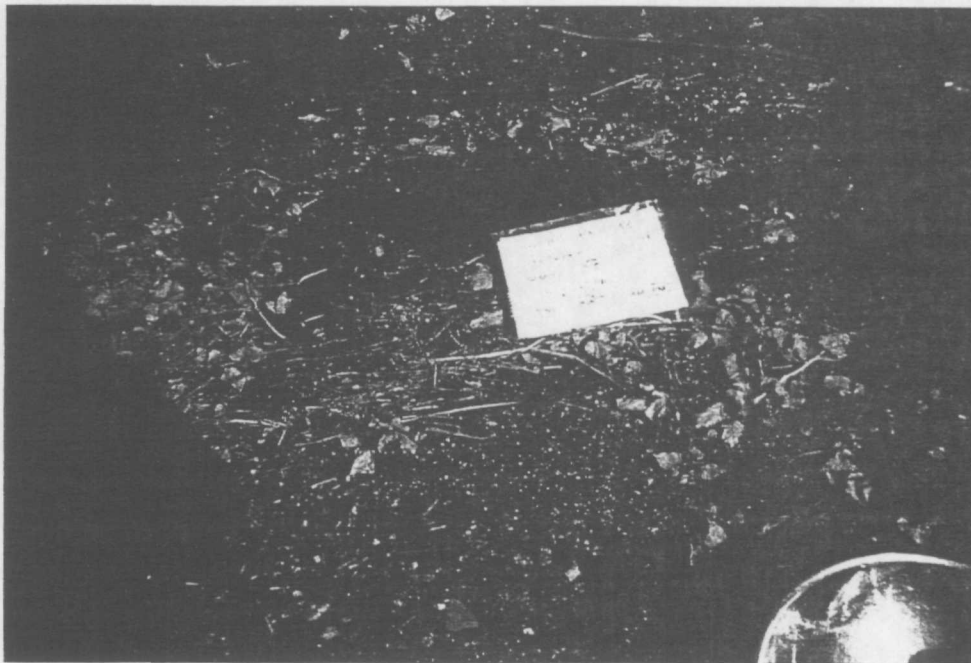
SAMPLE ID
(if applicable):
S7

DESCRIPTION: CLOSE-UP VIEW OF SOIL SAMPLE S7.

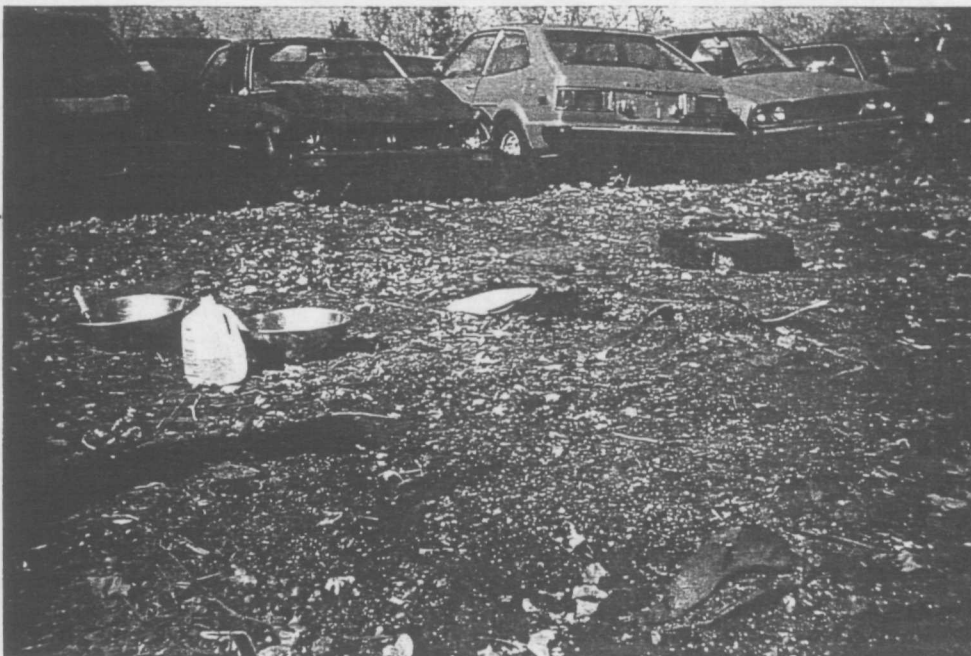
SAMPLE ID
(if applicable):
S7

DESCRIPTION: PERSPECTIVE VIEW OF SOIL SAMPLE S7. COLLECTED
IN OPEN AREA IN CENTER OF CAR JUNKYARD.

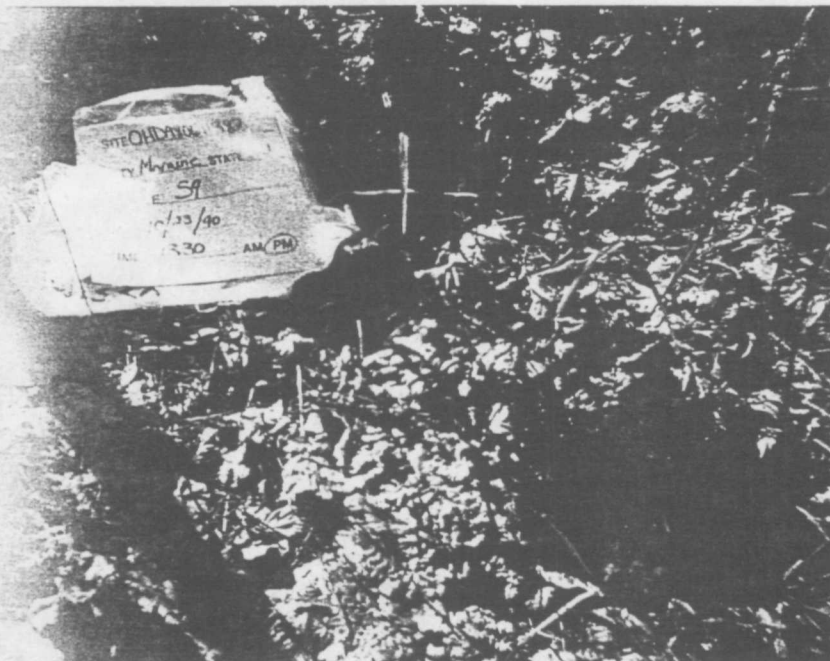
S9

DESCRIPTION: CLOSE-UP VIEW OF SOIL SAMPLE S9.

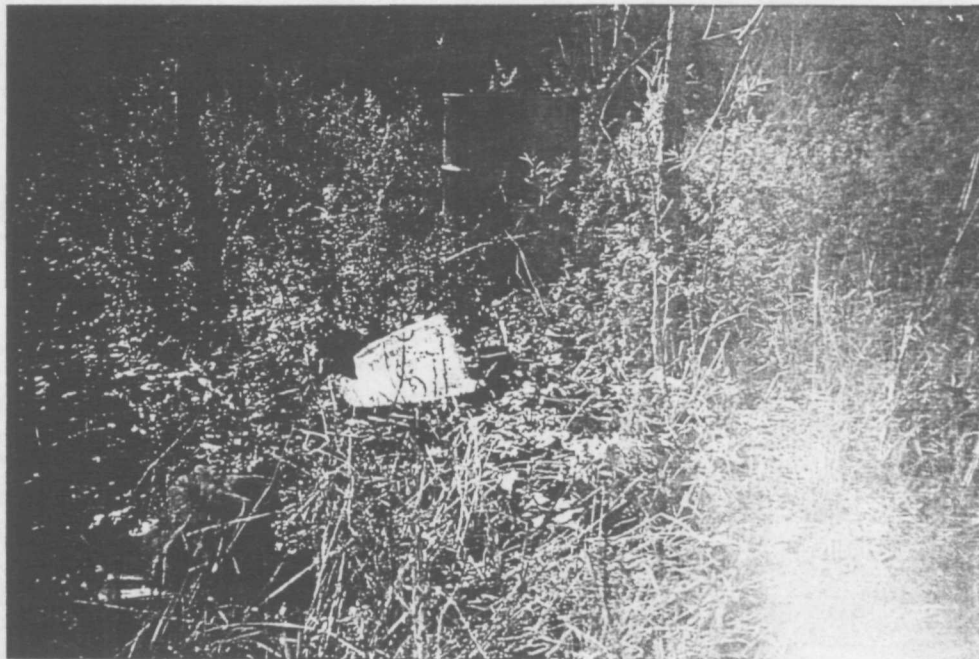
S9

DESCRIPTION: PERSPECTIVE VIEW OF SOIL SAMPLE S9. NOTE BARREL
IN BACKGROUND.

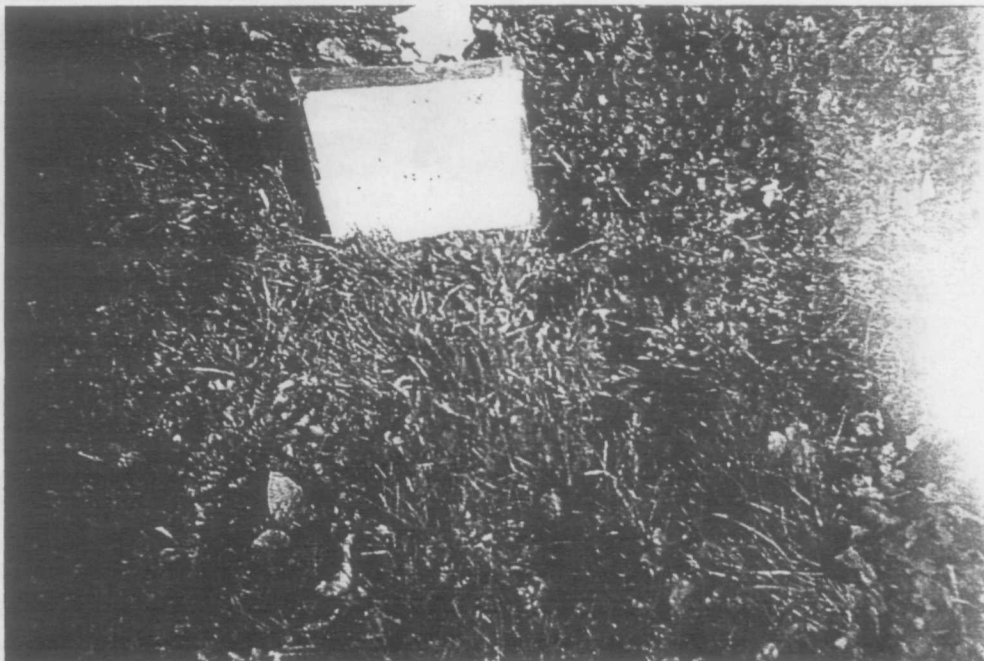
DESCRIPTION: CLOSE-UP VIEW OF SOIL SAMPLE S10. COLLECTED
OUTSIDE NORTHWEST BOUNDARY OF SITE.

Off-site soil sample S10 was collected 200 feet north of the SDD site and approximately 350 feet west of the auto salvage yard (see Figure 3-3 for the off-site soil sampling location). Sample S10 was collected as the potential background sample to determine the representative chemical content of the soil in the area of the site.

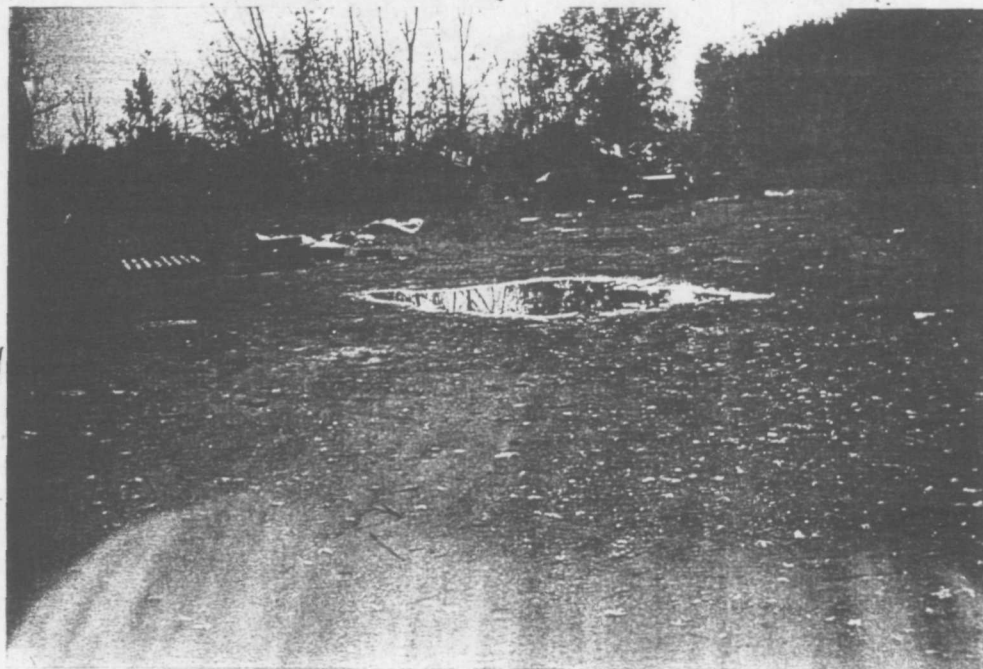
DESCRIPTION: VIEW OF DISCARDED PALLETs AT EDGE OF SITE
ACCESS ROAD IN WEST SECTION OF SITE.

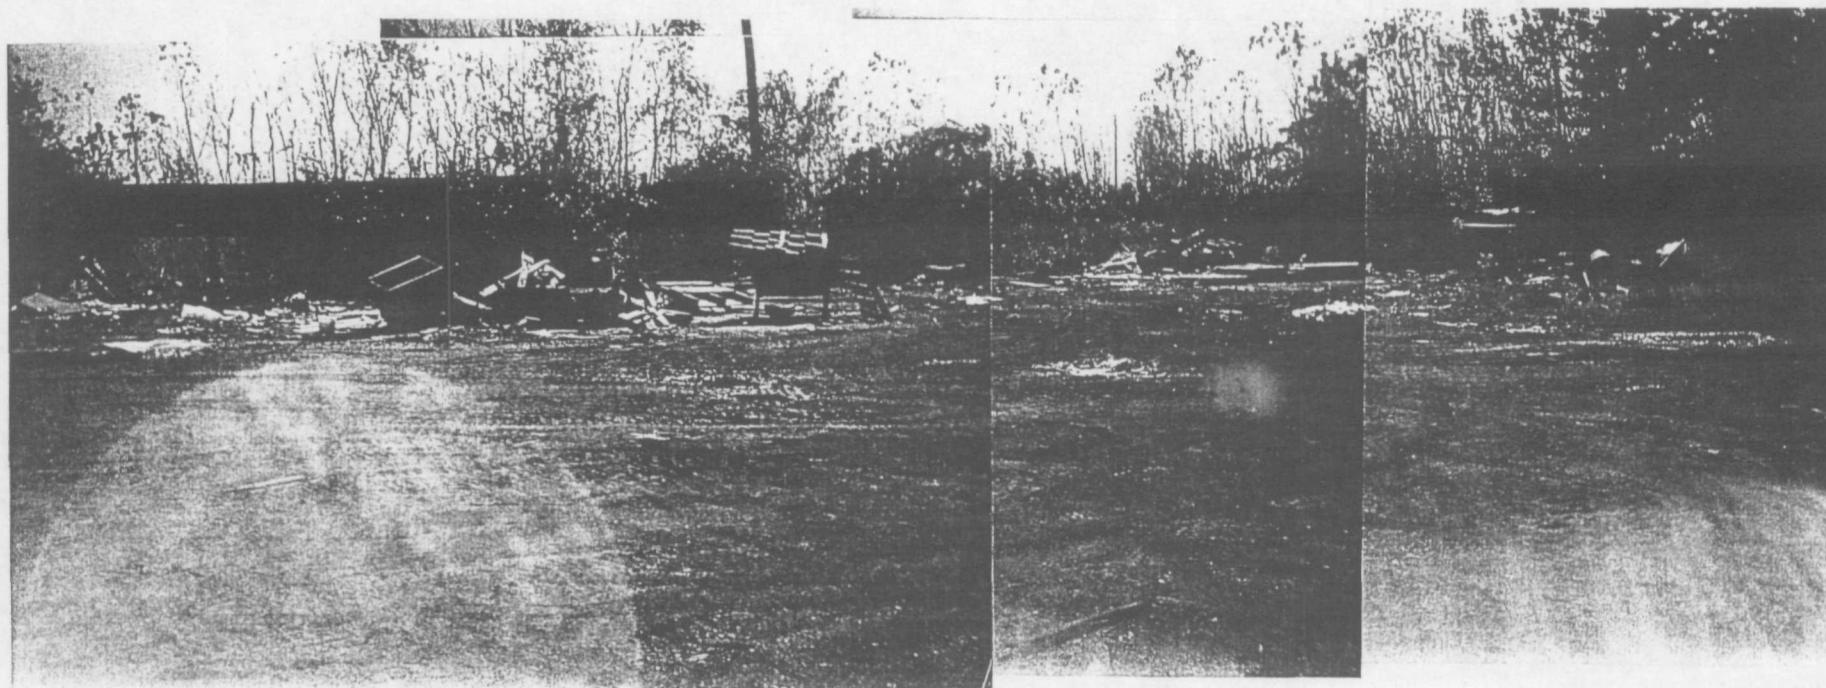
DESCRIPTION: VIEW OF INACTIVE BURNING AREA. NOTE FURNACE IN RIGHT-HAND CORNER.
ASH WAS SHOVELED INTO PIT BEHIND PICTURE.
